# SAFETY RECALL

## Electric Hydraulic Power Steering Pump

Reference: 21D / NHTSA 26V-363

2021-2025 (JL) Jeep Wrangler

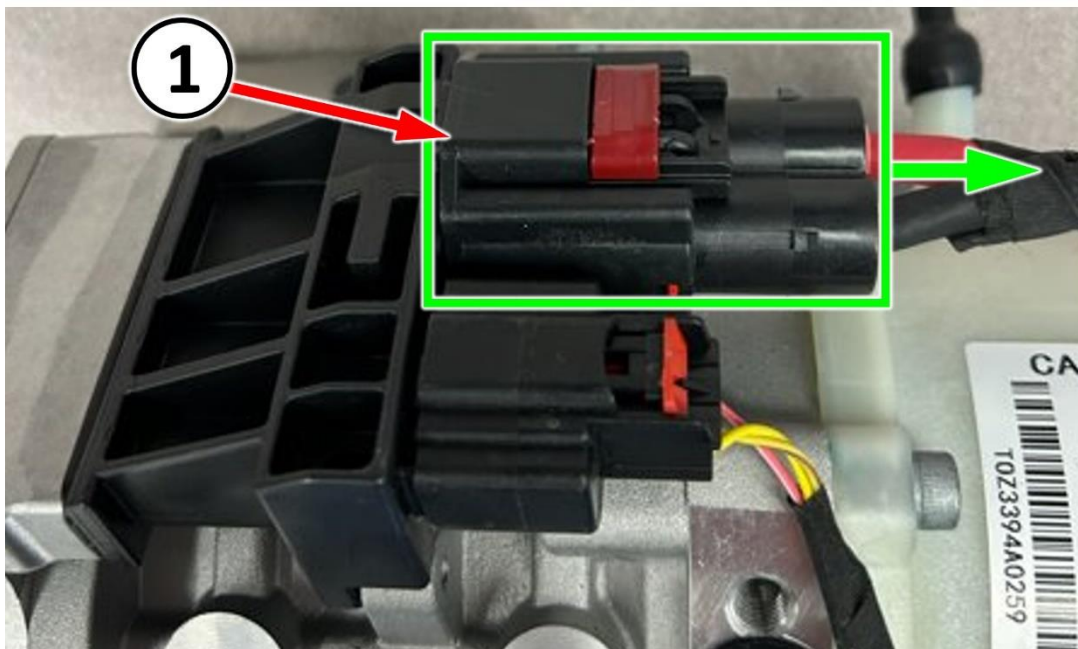
**Figure A2 – EHPS Electrical Connector Pull Test**

- b. Grasp the EHPS connector ONLY (not the wires) and pull to determine if it is securely connected to the EHPS pump. If connector releases, take photos to attach to repair claim. If connector does not detach, push on connector to ensure it is fully seated (Figure A2).

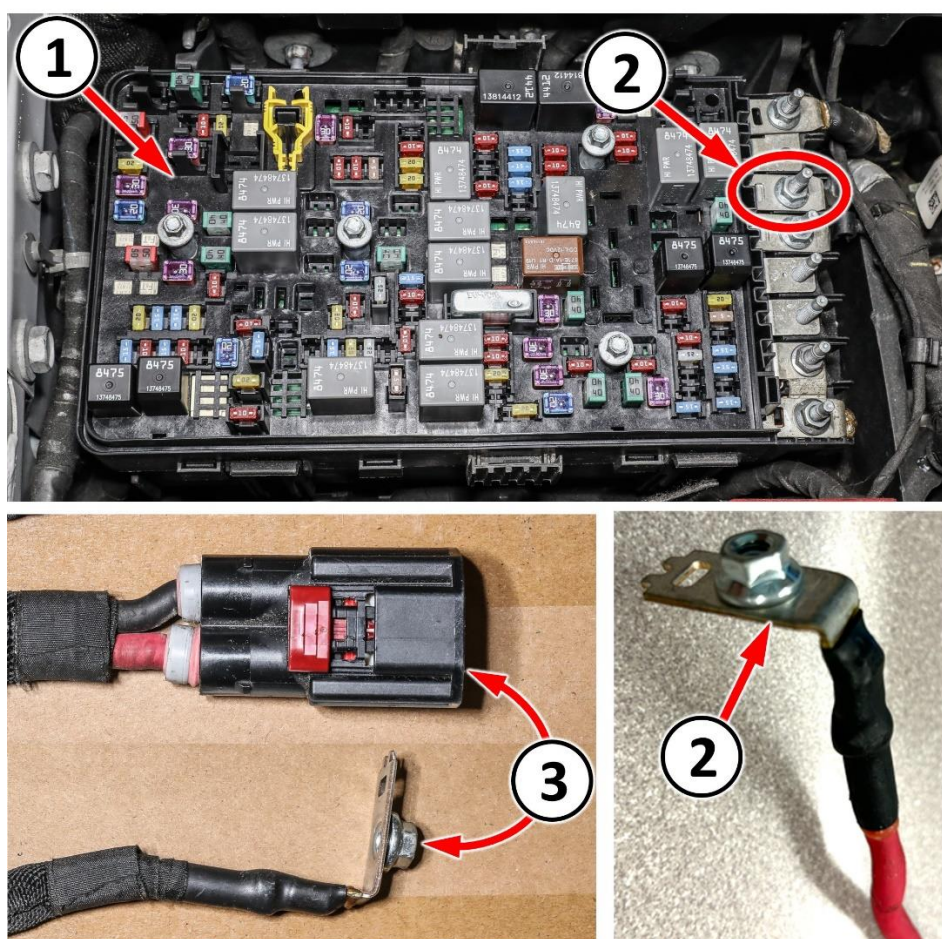
Figure A11 – EHPS Power Supply Eyelet D6630J in PDC

34. Remove the cover from the Power Distribution Center (PDC) under hood fuse box.
35. Locate the EHPS power supply eyelet D6630J on post #6 and remove eyelet off or the stud (Figure A11).
36. Verify continuity with multimeter between D6630J eyelet and D2704A connector cavity 2 red wire. Also verify the EHPS power circuit is isolated from the vehicle power circuit (Figure A11). **NOTE: If a continuity reading is still present between the EHPS power circuit wire and other vehicle power circuits, the wrong wire has been selected.**

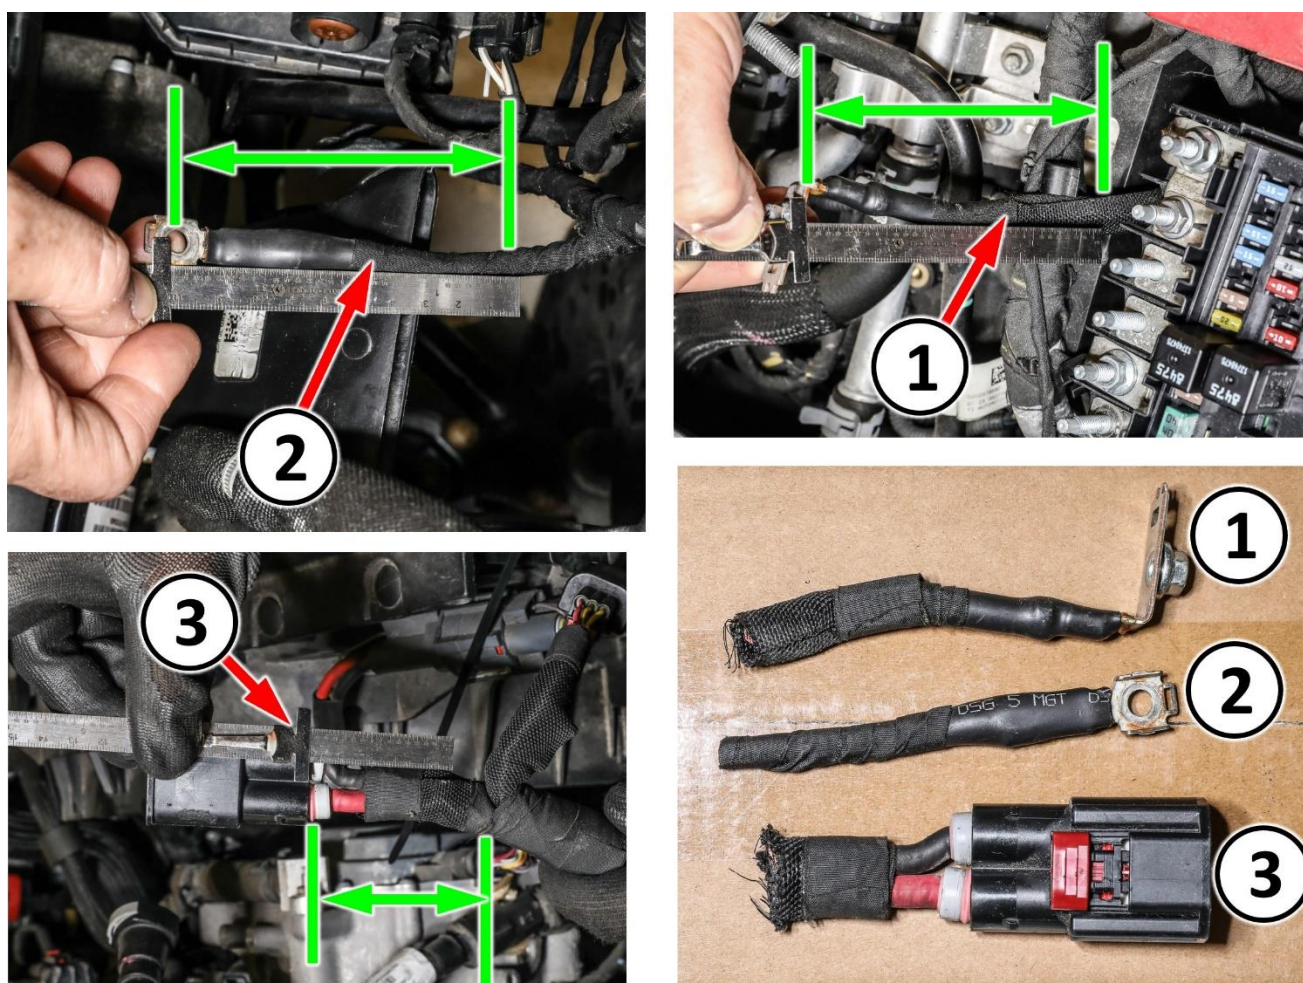
**Figure A12 – Remove EHPS Wire Harness Terminals**

37. After verification, cut EHPS power supply eyelet D6630J approximately 4 inches behind eyelet 90-degree bend and set aside for return for analysis (Figure A12).
38. After verification, cut ground eyelet G908A approximately 4 inches behind center of eyelet hole and set aside for return for analysis (Figure A12).
39. Cut 2way EHPS connector D2704A approximately 2 inches behind connector body taking special care not to cut through 3way connector D2704B circuits. Set aside for return for analysis (Figure A12).

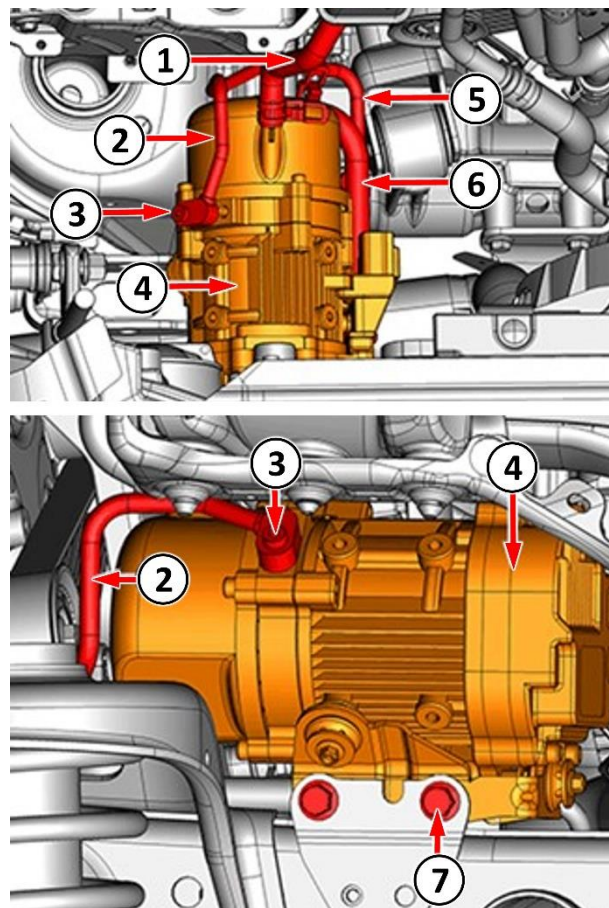
**Figure A15 – EHPS Pump**

48. Install the EHPS pressure pipe to the EHPS pump then install the EHPS pump pressure pipe bolt (Figure A15). Tighten the pressure pipe bolt to:  
2024 and prior: 20 N·m (15 Ft. Lbs.)  
2025 and later: 25 N·m (18 Ft. Lbs.)

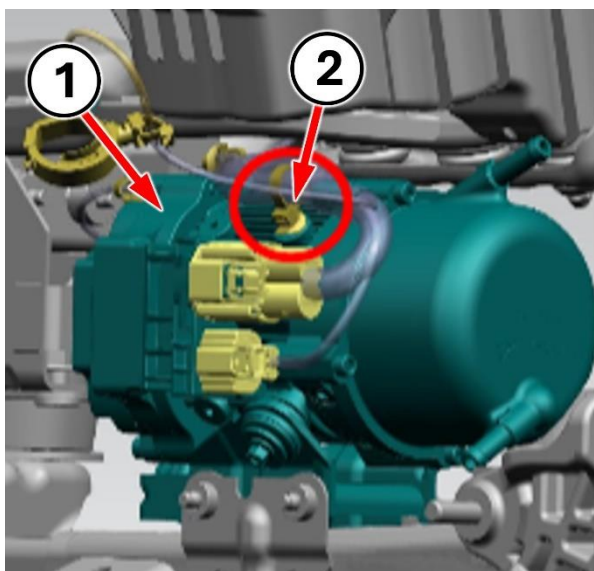
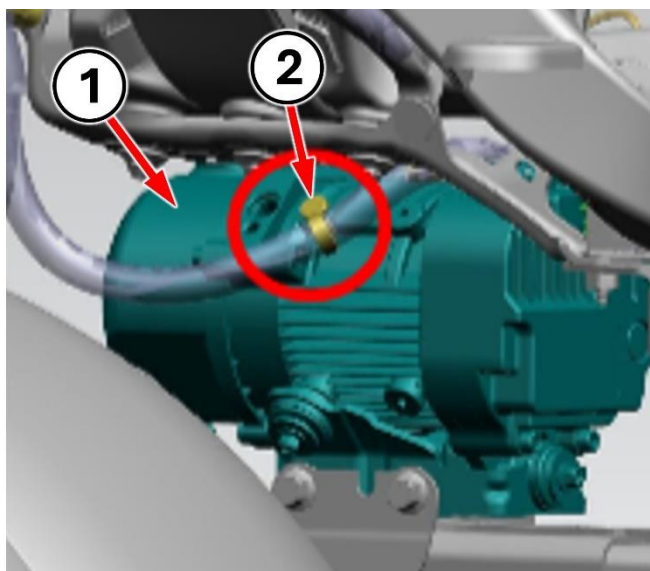
**Figure A17 – Power Steering Pump Wire Harness Routing and Clipping**

49. Install the EHPS wire harness fir tree clips to the EHPS pump/pump bracket (Figure A17).

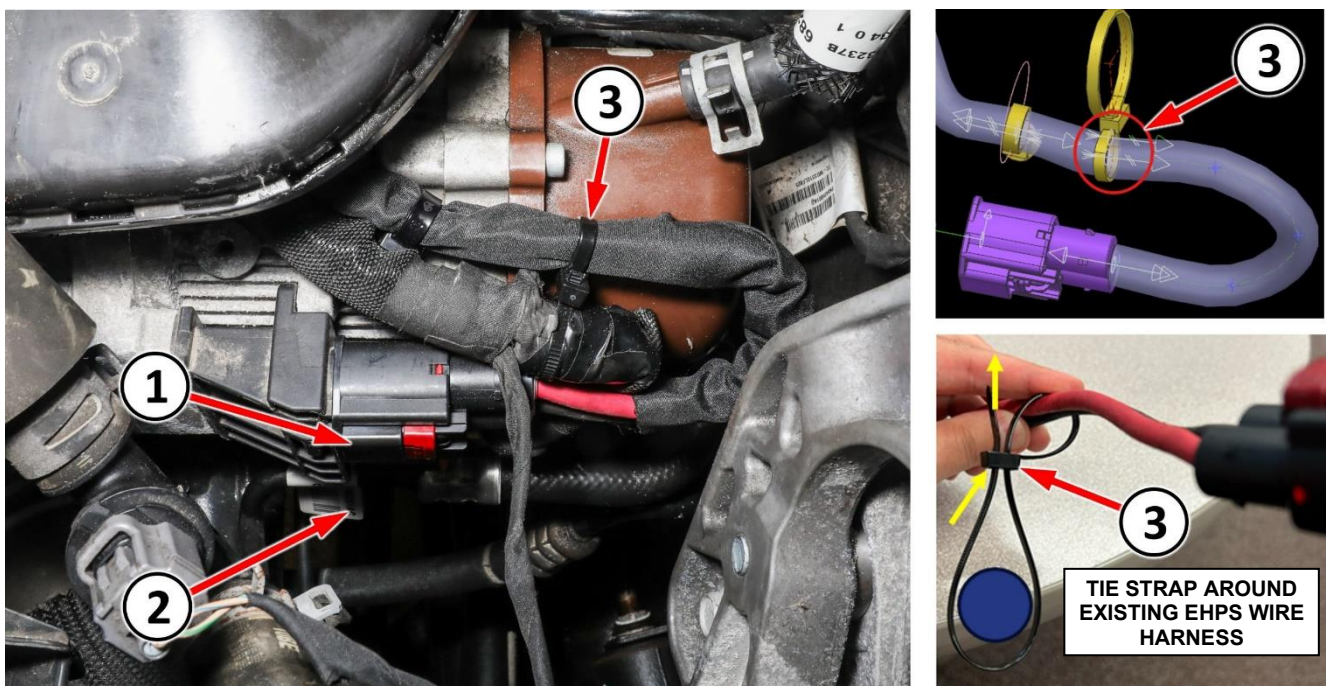
**Figure A18 – Power Steering Pump Wire Harness Routing and Clipping**

50. Connect the electrical connectors to the EHPS pump then engage the red CPA connector latch in locked position (Figure A18). Verify connection with Push-Pull-Push on connector, not on circuits.
51. Secure overlay to existing EHPS dash wiring bundle with double tie strap clip while making sure overlay is not in direct contact with sharp edges.

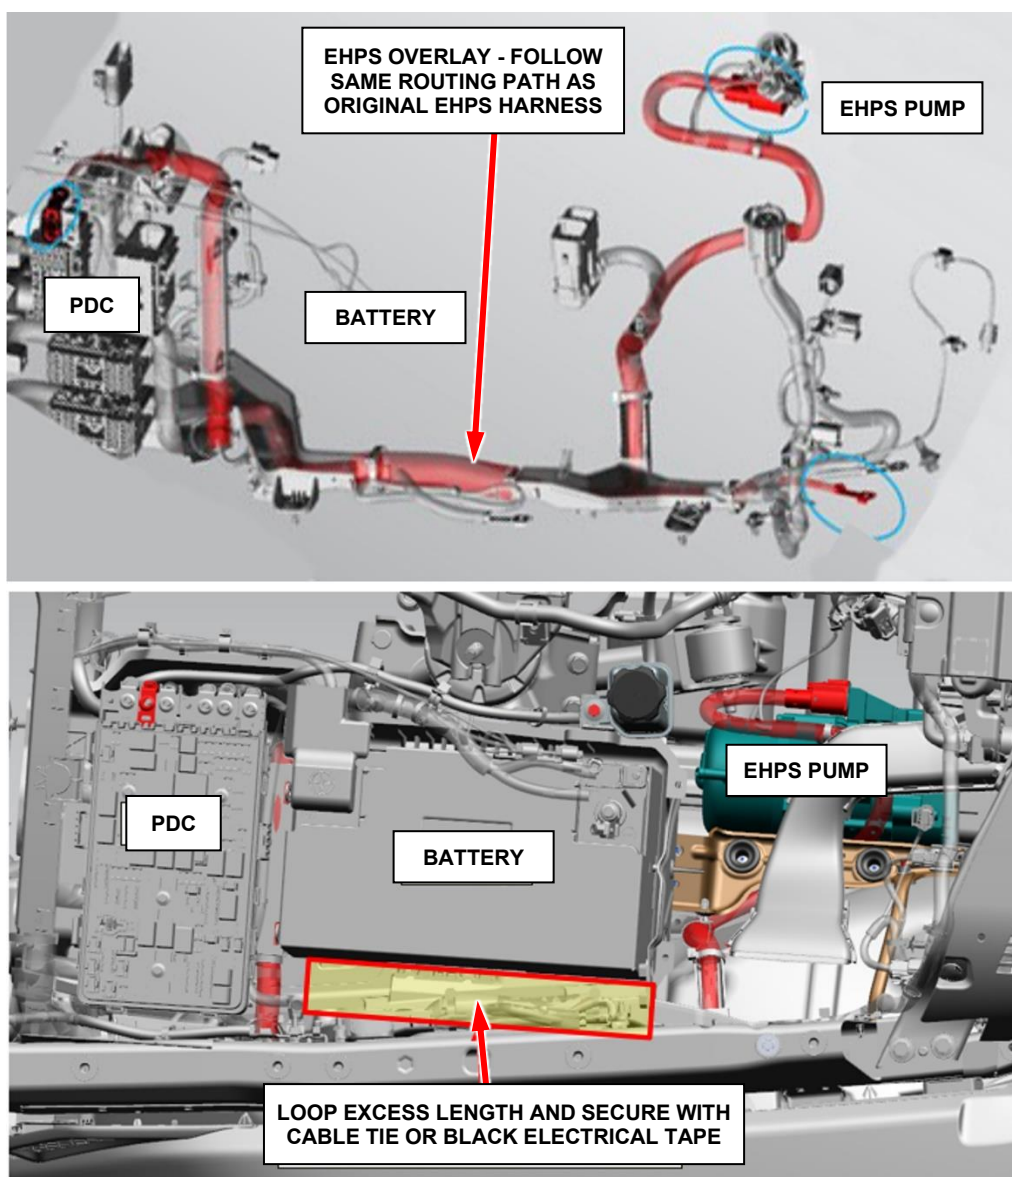
**Figure A19 – Power Steering Pump Wire Harness Overlay Routing**

52. Route remainder of EHPS overlay harness along existing dash harness bundle routing, securing double tie strap clips to existing dash harness wiring bundle. Make sure overlay is not in direct contact with sharp edges. Reference routing pictures below (Figure A19).
53. Loop and secure with cable tie or black electrical any excess overlay jumper wire length outboard of battery.

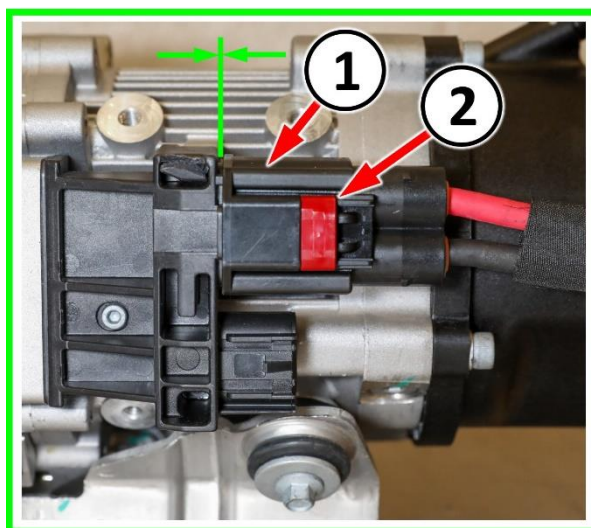
- a. Visually verify Electric Hydraulic Power Steering (EHPS) connector is fully mated to the pump interface with CPA fully engaged on the connector latch. If electrical connector is not fully mated or CPA is not engaged, take photos to attach to repair claim (Figure B2).

**Electrical Connector and CPA  
Fully Engaged, No Gap**

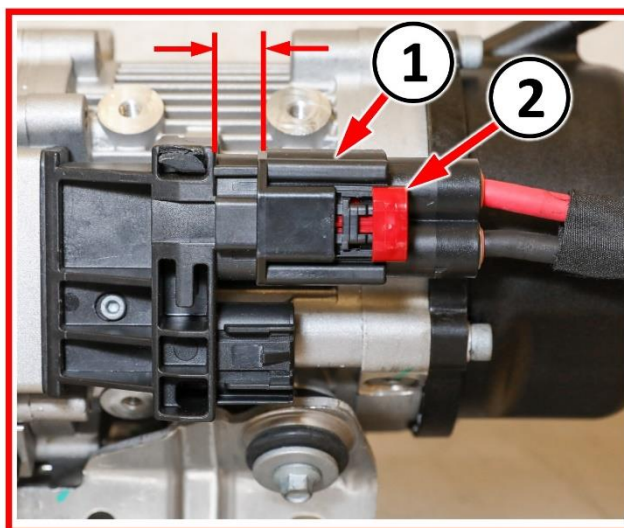
**Electrical Connector and/or CPA  
Not Fully Engaged, Gap Observed**

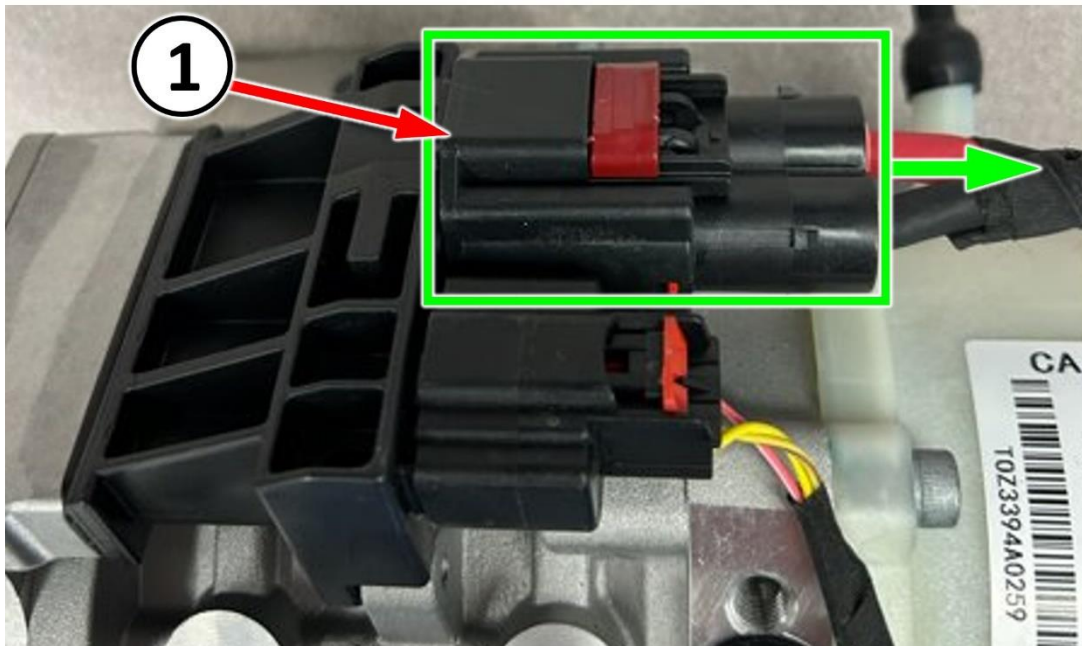
**Figure B3 – EHPS Electrical Connector Pull Test**

- b. Grasp the EHPS connector ONLY (not the wires) and pull to determine if it is securely connected to the EHPS pump. If connector releases, take photos to attach to repair claim. If connector does not detach, push on connector to ensure it is fully seated (Figure B3).

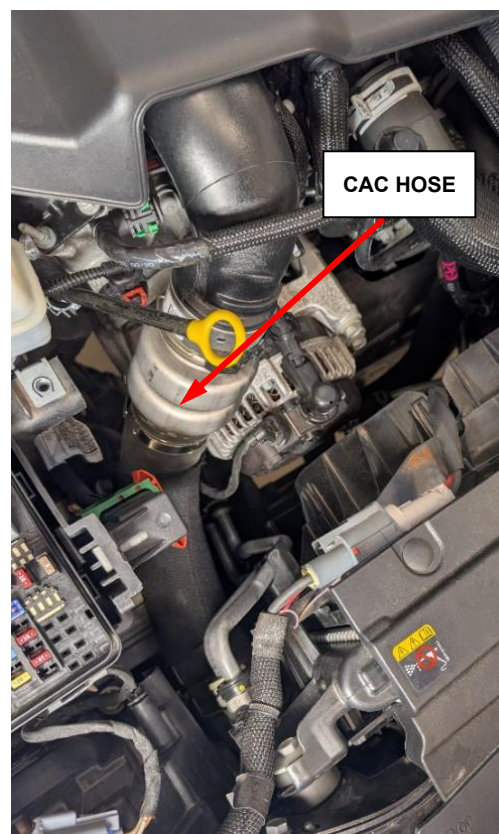
**Figure B6 – CAC Hose**

13. (3.0L Only) Remove the Charge Air Cooler (CAC) Hose (Figure B6). Refer to the detailed service procedures available in DealerCONNECT/ Service Library under: Service Info> 09 - Engine, 3.0L Turbo Diesel / Turbocharger System / COOLER and HOSES, Charge Air / Removal and Installation.

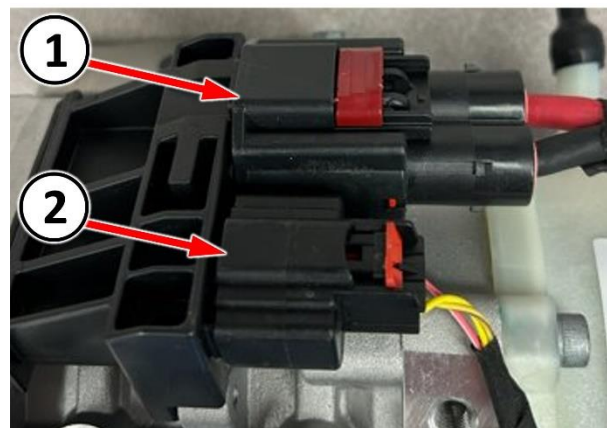
**Figure B7 – Electrical Connectors**

16. Disconnect the electrical connectors from the EHPS pump if not already done so, by sliding red CPA back and de-pressing connector latch (Figure B7).

1 - 2way connector D2704A  
2 – 3way connector D2704B

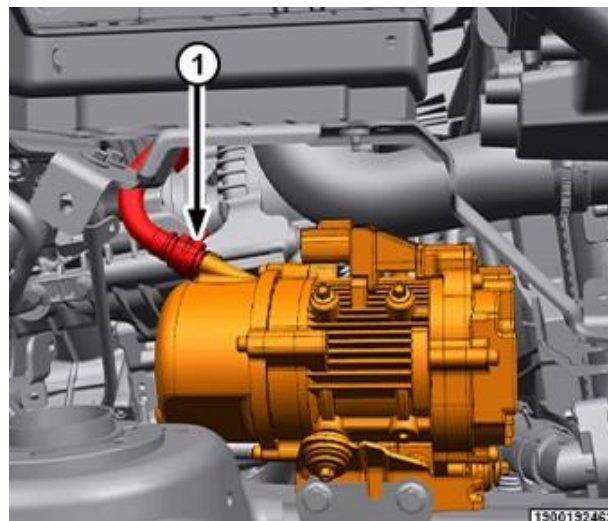
**Figure B9 – EHPS Pump Return Hose**

18. Position a drain pan before disconnecting pump hoses and pipes.
19. Pinch off the EHPS pump return hose with a suitable clamp.
20. Disconnect the EHPS pump return hose from the EHPS pump (Figure B9).

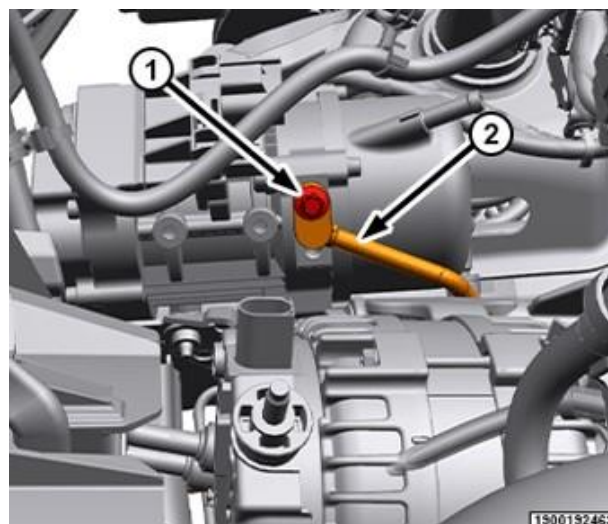
**Figure B10 – EHPS Pump Pressure Pipe**

21. Remove the EHPS pump pressure pipe bolt and remove the pressure pipe from the EHPS pump (Figure B10).

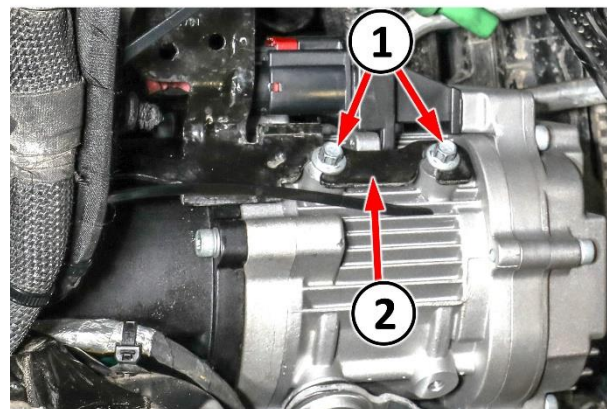
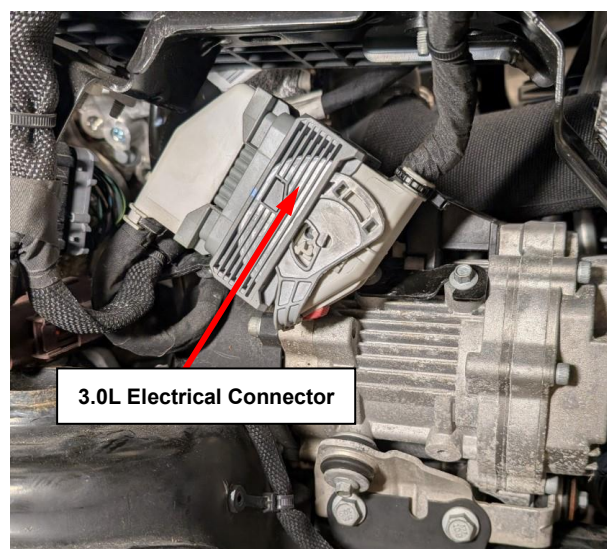
**Figure B11 – Wire Harness Bracket**

**NOTE:** For 3.0L vehicles, disconnect the electrical harness connector to gain bolt access (lower image in Figure B11).

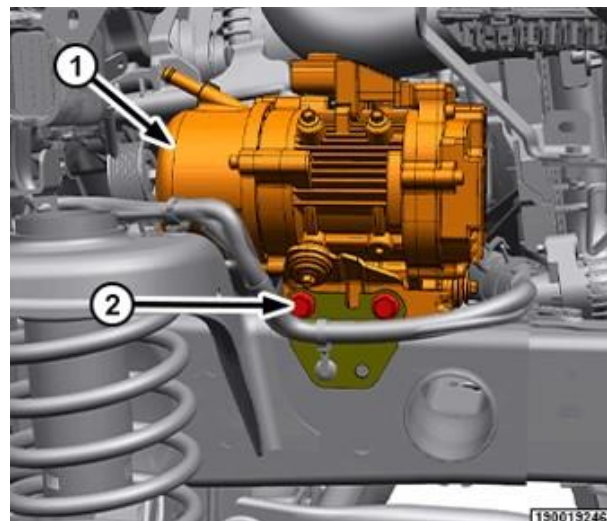
**Figure B12 – EHPS Pump**

23. Remove the EHPS pump frame bracket bolts (Figure B12).
24. Remove the EHPS pump from the vehicle with reservoir attached (Figure B12).
25. Obtain the **NEW** EHPS pump and transfer the reservoir to the **NEW** pump.
26. Set aside the replaced EHPS pump from the vehicle for return for analysis.

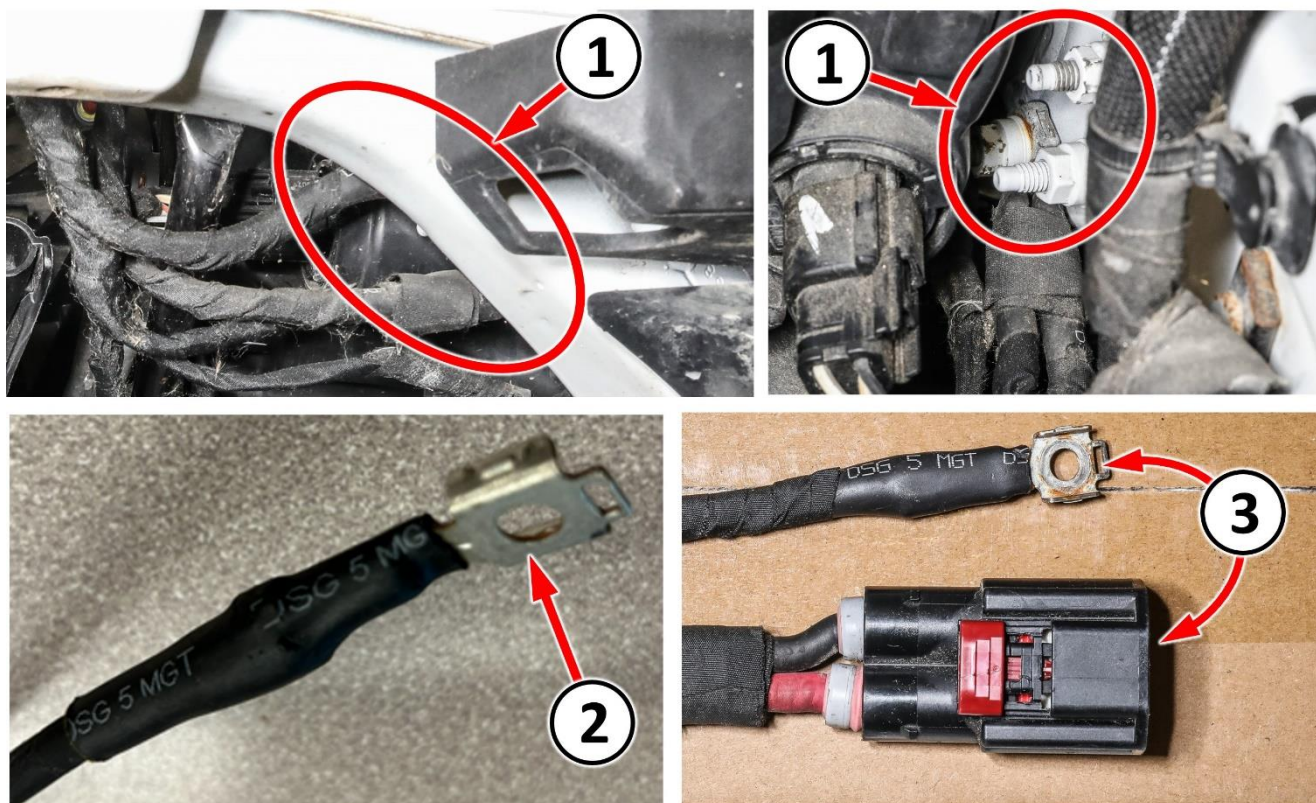
**Figure B13 – EHPS ground G908A - Near Right Side Headlamp**

27. Locate EHPS ground G908A on body of vehicle near the right-side headlamp on one of three studs (Figure B12). NOTE: The EHPS ground connection is often located on the lower stud but may vary depending on vehicle build configuration so MUST be verified.
28. Remove the ground nut and eyelet off the stud then verify continuity with a multimeter between G908A ground eyelet and EHPS connector D2704A cavity 1 black wire. Also verify the EHPS ground circuit is isolated from chassis ground (Figure B12). NOTE: If a continuity reading is still present between the EHPS ground circuit wire and chassis ground, the wrong wire has been

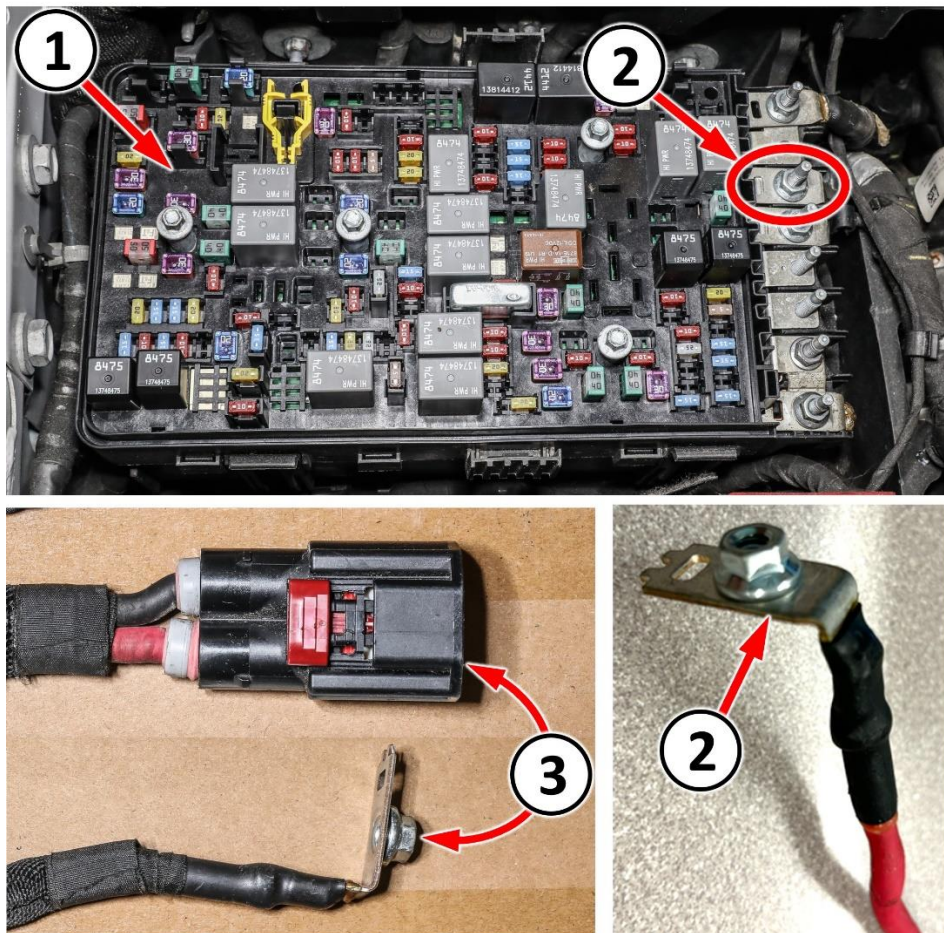
**Figure B14 – EHPS Power Supply Eyelet D6630J in PDC**

29. Remove the cover from the Power Distribution Center (PDC) under hood fuse box.
30. Locate the EHPS power supply eyelet D6630J on post #6 and remove eyelet off or the stud.
31. Verify continuity with multimeter between D6630J eyelet and D2704A connector cavity 2 red wire. Also verify the EHPS power circuit is isolated from the vehicle power circuit (Figure B13). NOTE: If a continuity reading is still present between the EHPS power circuit wire and other vehicle power circuits, the wrong wire has been selected.

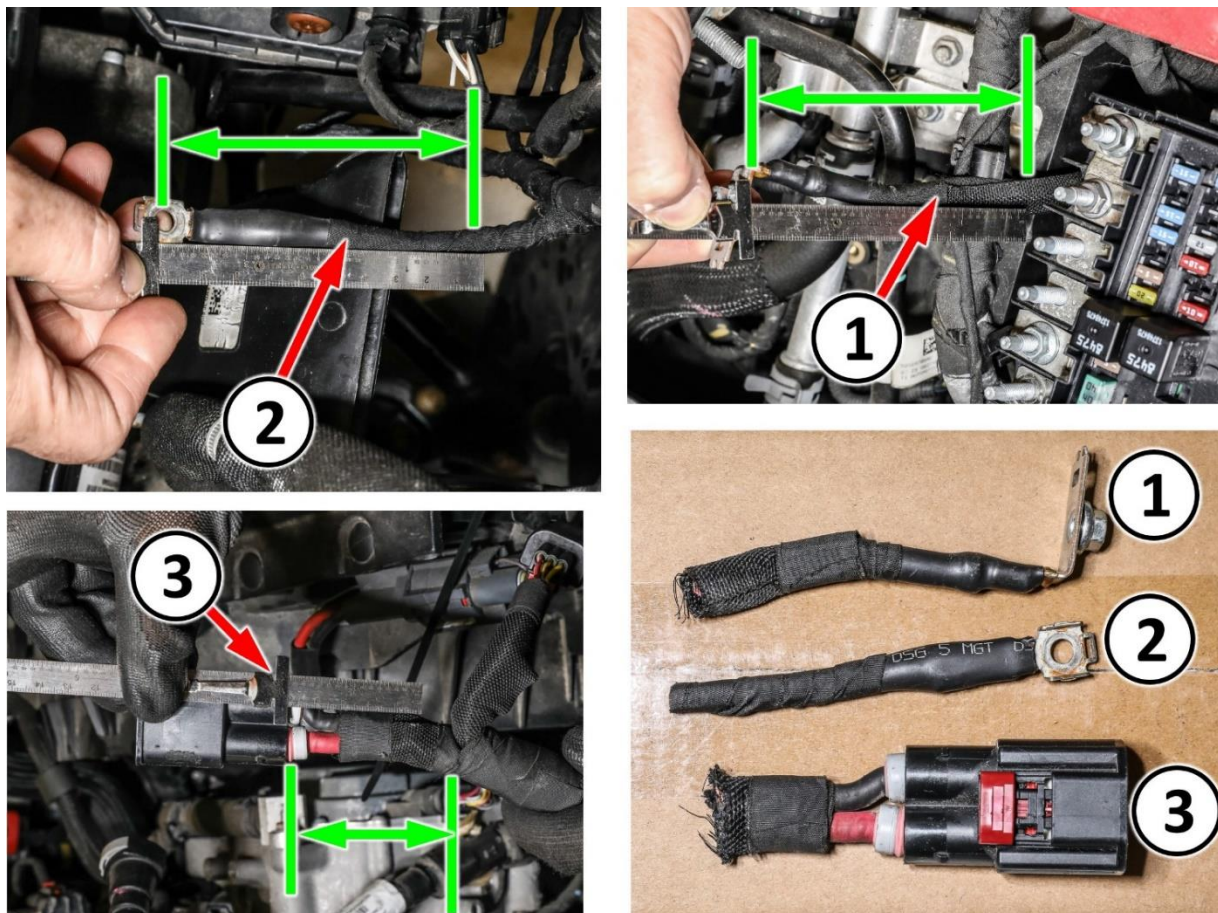
**Figure B15 – Remove EHPS Wire Harness Terminals**

32. After verification, cut EHPS power supply eyelet D6630J approximately 4 inches behind eyelet 90-degree bend and set aside for return for analysis (Figure B15).
33. After verification, cut ground eyelet G908A approximately 4 inches behind center of eyelet hole and set aside for return for analysis (Figure B15).
34. Cut 2way EHPS connector D2704A approximately 2 inches behind connector body taking special care not to cut through 3way connector D2704B circuits. Set aside for return for analysis (Figure B15).

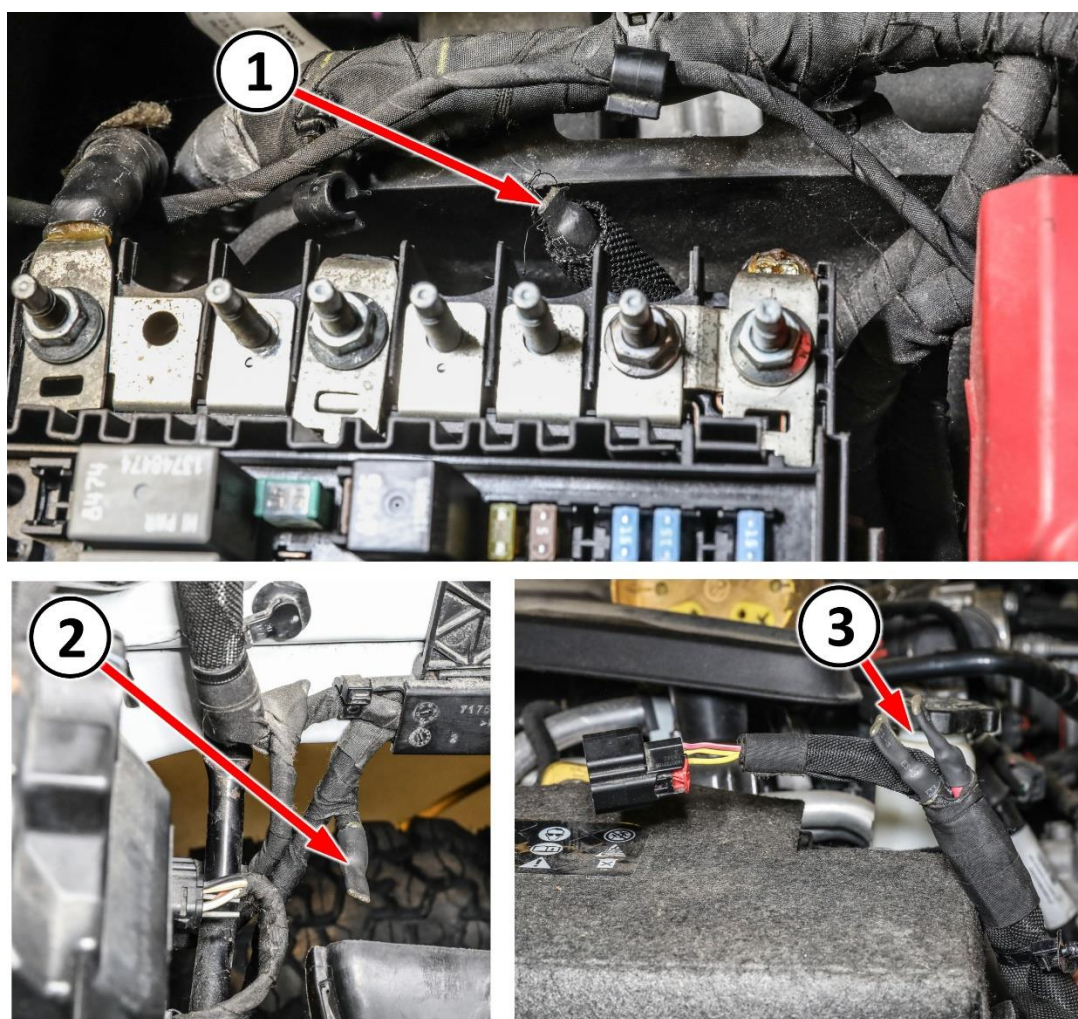
**Figure B16 – Seal Exposed Ends of Cut EHPS Wires**

35. Use locally sourced heat shrink tubing to seal the exposed end where EHPS power supply eyelet D6630J was removed (Figure B16).
36. Use locally sourced heat shrink tubing to seal the exposed end where EHPS ground eyelet G908A was removed (Figure B16).
37. Use locally sourced heat shrink tubing to seal the exposed ends where EHPS connector D2704A was removed (Figure B16).

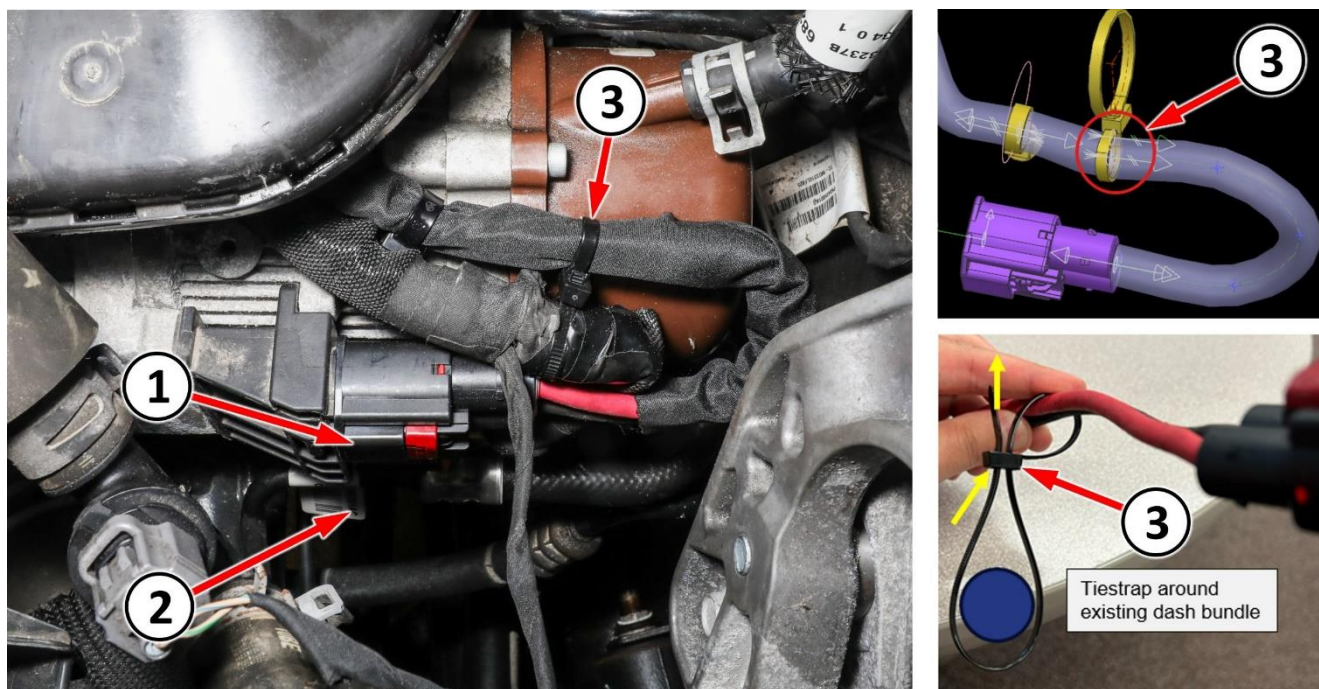
**Figure B20 – Power Steering Pump Wire Harness Routing and Clipping**

46. Connect the electrical connectors to the EHPS pump then engage the red CPA connector latch in locked position (Figure B20). Verify connection with Push-Pull-Push on connector, not on circuits.
47. Secure overlay to existing EHPS dash wiring bundle with double tie strap clip while making sure overlay is not in direct contact with sharp edges.

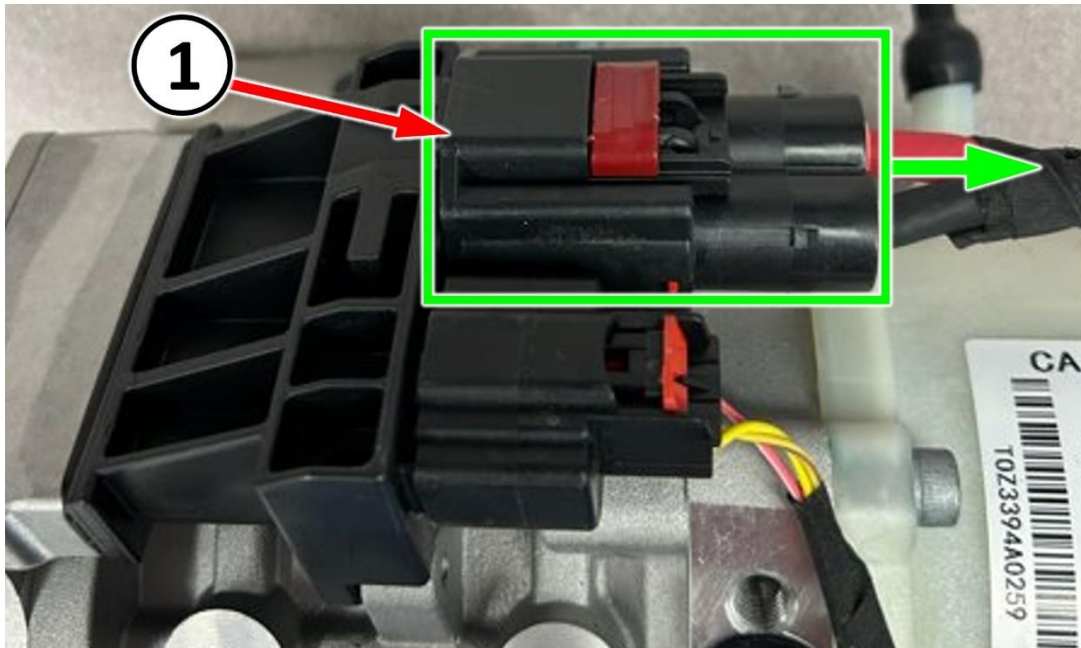
**Figure C2 – EHPS Electrical Connector Pull Test**

- b. Grasp the EHPS connector ONLY (not the wires) and pull to determine if it is securely connected to the EHPS pump. If connector releases, take photos to attach to repair claim. If connector does not detach, push on connector to ensure it is fully seated (Figure C2).
